# Testing proposed delineators to demarcate pedestrian paths in a shared space environment

Report of design trials conducted at University  
College London Pedestrian Accessibility and  
Movement Environment Laboratory (PAMELA)

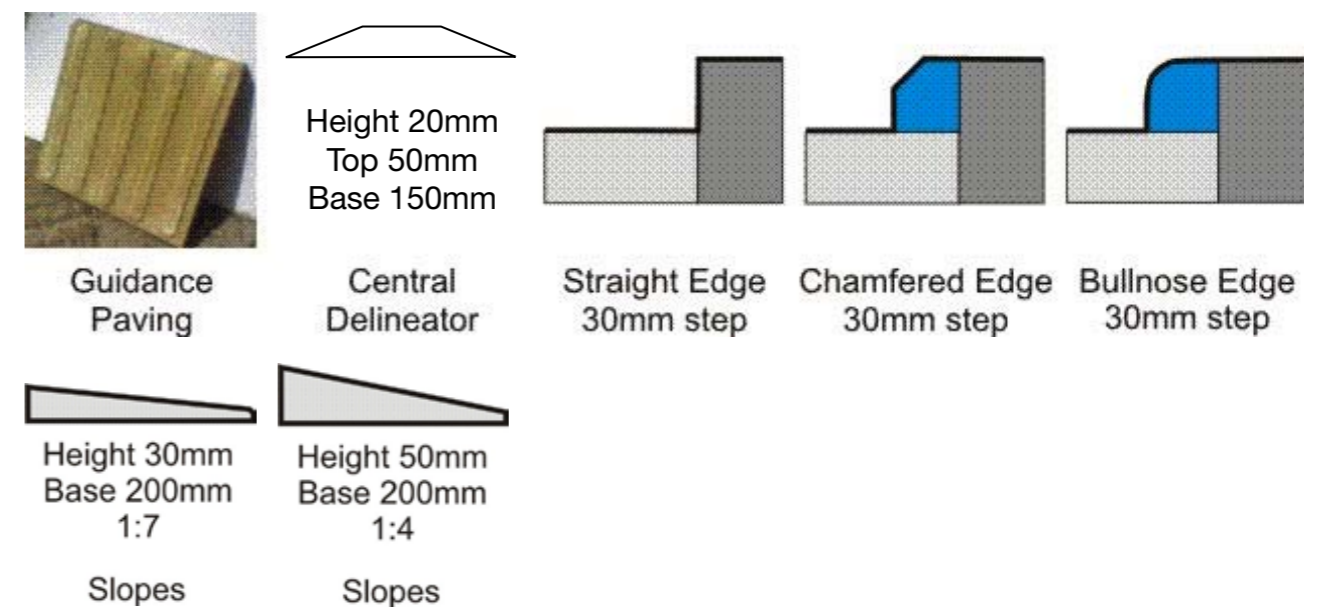
Guidance paving 400mm width  
Central delineator  
30mm step kerb  
30mm bullnose kerb  
30mm chamfered kerb  
30mm by 200mm sloped kerb (1:7 gradient)  
50mm by 200mm sloped kerb (1:4 gradient)

The guidance paving was in accordance with the Department for Transport's 'Guidance on the use of tactile paving surfaces', with the exception of the width that was tested: a 400mm width was tested rather than the recommended 800mm. The reduced width has been proposed by local authorities reluctant to use 800mm.

The central delineator tested was a trapezoidal strip 20mm high, 150mm wide with sloping sides and a flat top of 50mm. This is prescribed in 'Guidance on the use of tactile paving surfaces' for use to separate the pedestrian and cyclist sides of a segregated shared use cycle path.

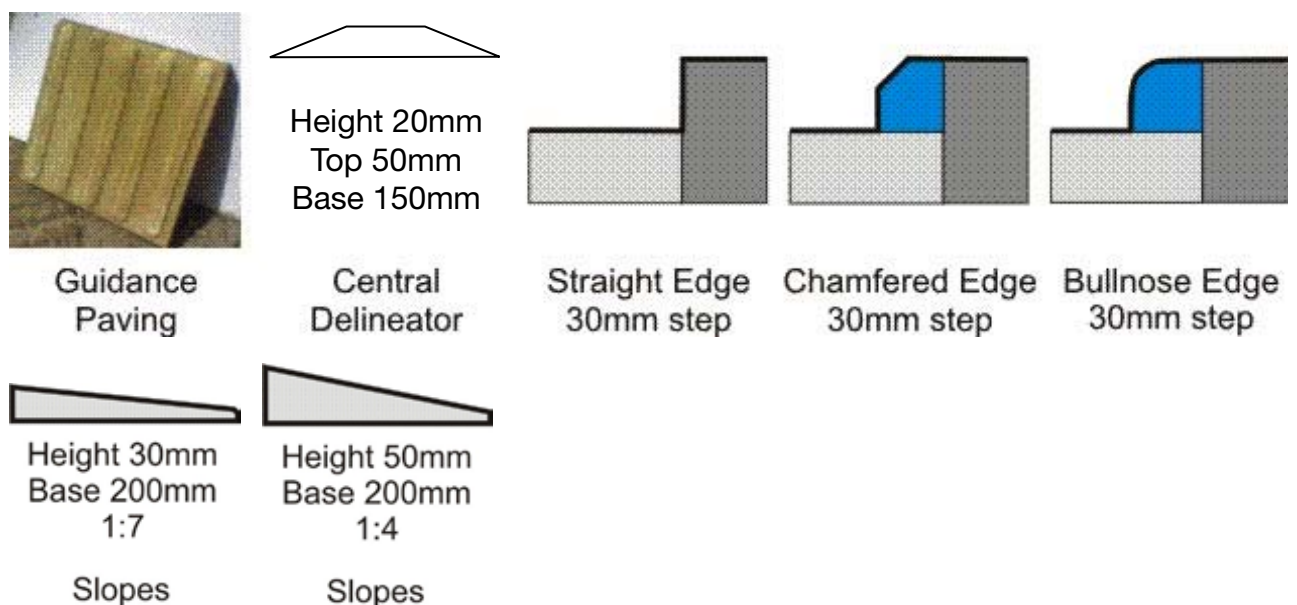
- Guidance paving 400mm width
- Central delineator
- 30mm step kerb
- 30mm bullnose kerb
- 30mm chamfered kerb
- 30mm by 200mm sloped kerb (1:7 gradient)
- 50mm by 200mm sloped kerb (1:4 gradient)

The guidance paving was in accordance with the Department for Transport's 'Guidance on the use of tactile paving surfaces', with the exception of the width that was tested: a 400mm width was tested rather than the recommended 800mm. The reduced width has been proposed by local authorities reluctant to use 800mm.

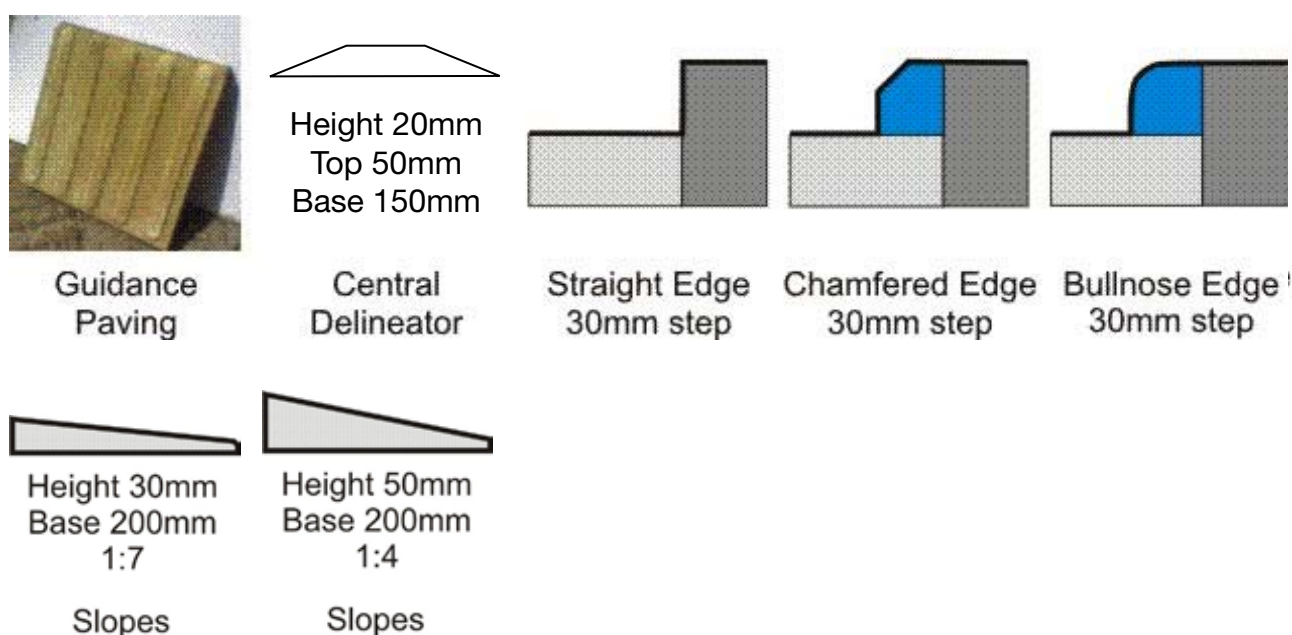
**Figure 1: Delineators**

In some form, all of these delineators have been used or are proposed for use in shared space street schemes to delineate the edge of the pedestrian path, but have not previously been tested for use in these situations.

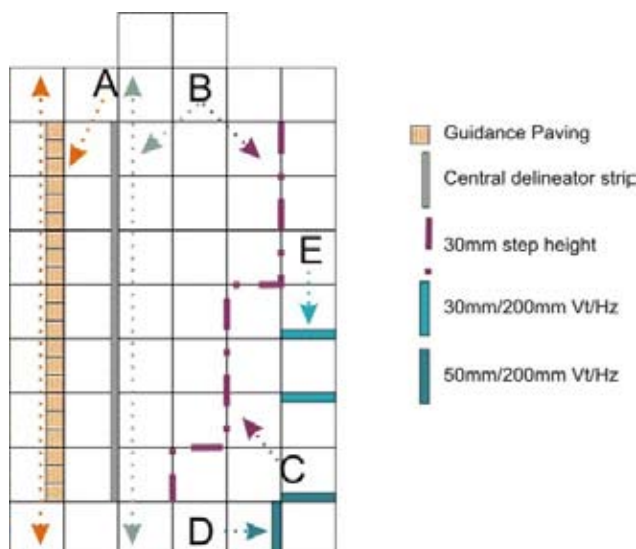
**Figure 2:** The layout of delineators on the platform for blind and partially sighted participants

The letters refer to the start point for each trial and arrows indicate the direction to be taken in each case. In between trials, the 30mm step edge type would be changed between straight, bullnose and chamfered. The straight edge step was achieved by raising some modules 30mm higher than the adjacent ones.

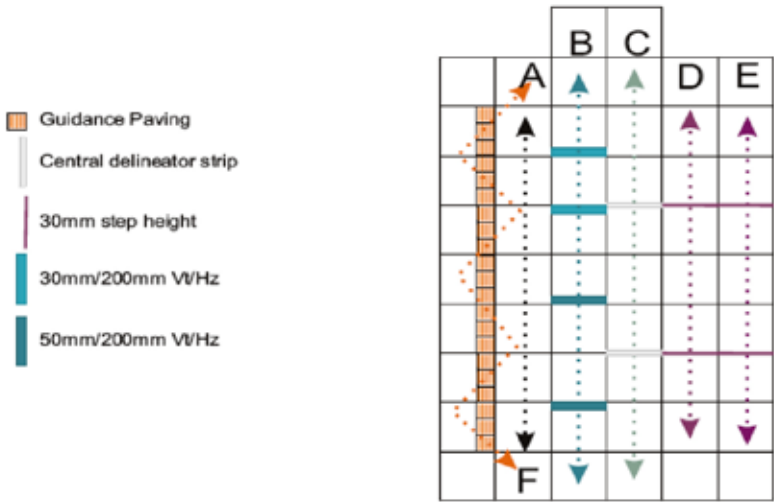
**Figure 3:** Layout of delineators for mobility impaired participants

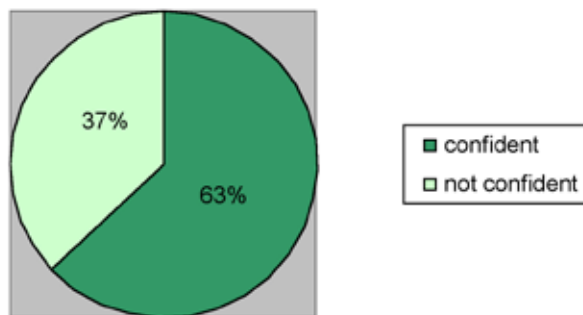
**Figure 6:** Guidance paving: Blind and partially sighted participants  
Confidence using to navigate within the space

Results from the video and Total Heart Beat Index analysis were positive. Video analysis indicates that 100% of participants were able to detect and navigate with this delineator, though as noted above their confidence in following it varied. The guidance paving produced the fastest walking speeds for 5 participants, suggesting they felt most comfortable with this delineator, and it also produced a low Total Heart Beat Index for the majority of participants in comparison to some of the other delineators such as the bullnose, chamfered and straight edge kerbs.

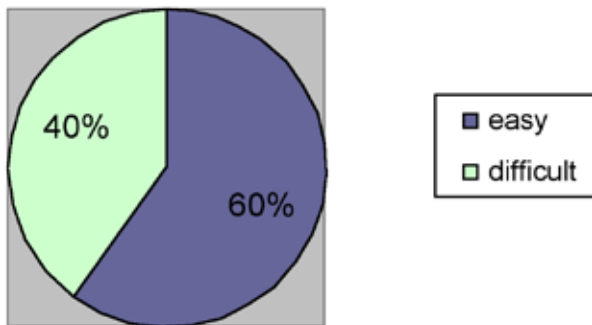
**Figure 7:** Guidance paving: Mobility impaired participants  
Ease of crossing

Results from the video analysis confirm that all the mobility participants were able to cross the guidance paving. Therefore in terms of the number of fails, the guidance paving was no worse than many of the other delineators. However, 53% (8/15) of the participants had their slowest travelling speed when using it, suggesting that it did cause them difficulty. In addition, the guidance paving produced the highest Total Heart Beat Index in 33% (5/15) of the participants, which again suggests difficulty. As noted above 40% (6 participants) reported that they found the guidance paving difficult to cross.

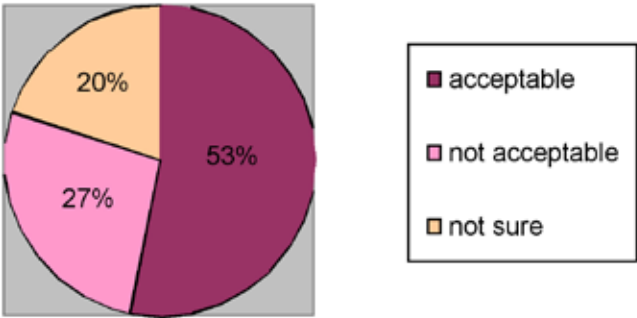
**Figure 9:** Guidance paving: Mobility impaired participants  
Acceptability in the pedestrian environment

The negative comments made by some mobility participants may be partly due to the positioning of the guidance paving on the platform. With only a single day between the tests for blind and partially sighted participants and those for mobility impaired participants, there was not enough time to relocate the guidance paving (which was done for all the other delineators). This meant that the participants had to zigzag down the platform over the guidance paving. Reviewing by video analysis the path taken by each participant, it shows that they all crossed the guidance paving twice as often as they did for any of the other delineators in each pass (a 'pass' being movement from one end of the platform to the other). In addition, since they had to make multiple turns in each pass to cross the delineator repeatedly, it may have been harder work for them than when they negotiated the other delineators.

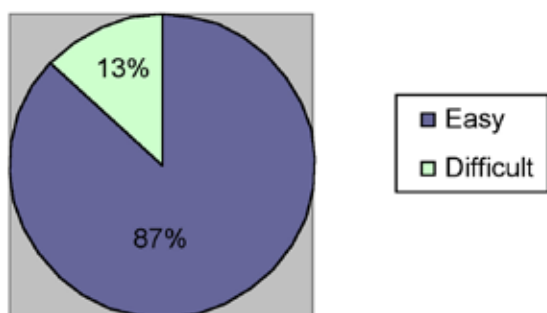
**Figure 12:** Central delineator profile: Mobility impaired participants  
Ease of crossing

The video analysis also presents positive results for the central delineator, demonstrating that none of the mobility impaired participants failed to cross this design feature. The central delineator produced the slowest Total Heart Beat Index in 20% (3) of participants, suggesting that they found this design feature the least stressful, while 27% (4) recorded their fastest travelling speed while crossing the central delineator. Further indication that this delineator was relatively easier to cross than other delineators can be seen from the fact that this delineator did not produce the highest, or a relatively high, THBI or lowest travelling speed for any of the participants with the exception of one participant. (This participant, who used a rolator, also failed to cross 4 of the 7 delineators: this was not the delineator with which she had the most difficulty.)

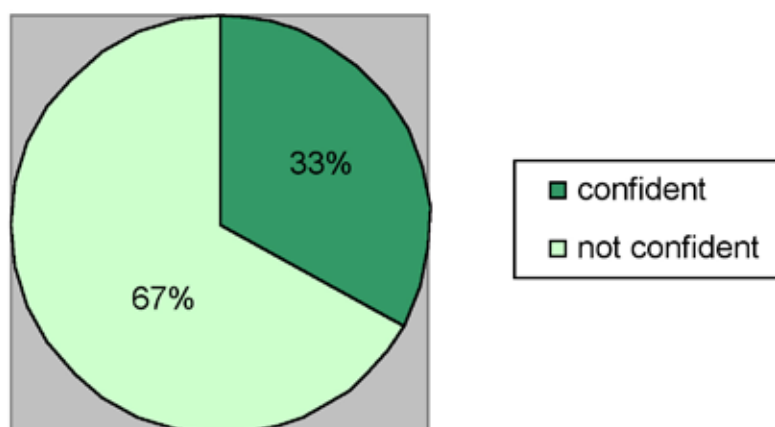
**Figure 19:** Straight edge kerb: Blind and partially sighted participants  
Confidence using to navigate within the space when approached from the upper side

Results from the video analysis show that one participant failed to detect the straight edge kerb from the lower side, while two participants were able to detect the edge but were not able to follow it when they had approached from the lower side and then got onto the upper path.

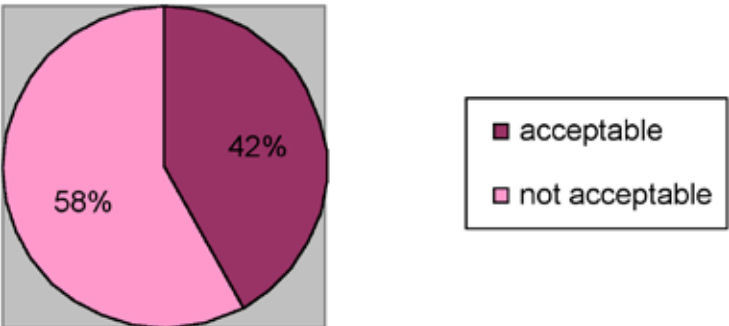
Analysis of the video data indicates that two participants failed to cross the kerb independently and needed assistance. Two participants demonstrated their slowest travelling speed when using this edging and an additional one participant recorded their highest THBI when attempting to cross this design feature, suggesting these participants had the most difficulty with this compared to other delineators.

**Figure 22:** Straight edge kerb: Mobility impaired participants  
Acceptability in the pedestrian environment

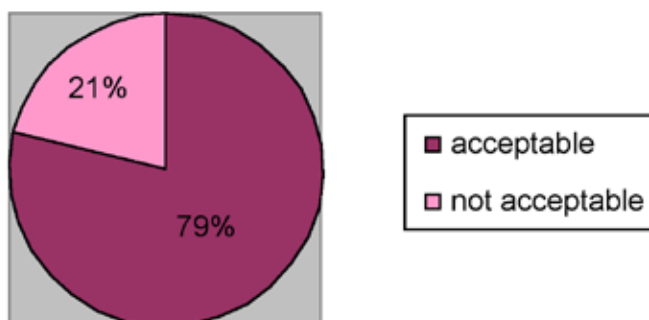
**Figure 29:** Bullnose edge kerb: Mobility impaired participants  
Acceptability in the pedestrian environment

However the video analysis suggests that the bullnose edging incurred the most failures out of the three kerb edges, with 21% (3) participants being unable to cross this design feature. The bullnose edge also produced the highest Total Heart Beat Index of all the design features in two of the participants. Thus, although the majority of participants found this delineator acceptable, some participants nevertheless had significant difficulty negotiating it.

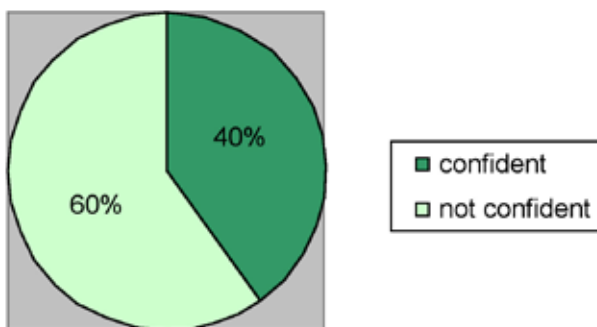
**Figure 32:** Chamfered edge kerb: Blind and partially sighted participants  
Confidence using to navigate within the space

Interpretation of the video data suggests that two participants were able to detect the chamfered edge kerb from the upper side but were not able to follow it due to the corners. In addition video analysis revealed that two participants had difficulty following the edge when they had approached it from the lower side and then got on to the path.

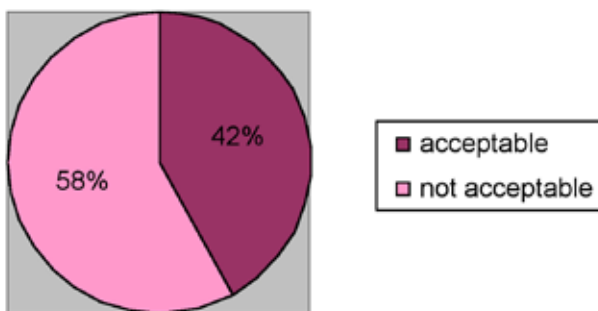
**Figure 35:** Chamfered kerb: Mobility impaired participants  
Acceptability in the pedestrian environment

Analysis of the video data suggests that only one participant failed to negotiate this edge independently. Two participants recorded their slowest travelling speed when attempting to cross this design feature, while it produced the highest Total Heart Beat Index in 3 participants.

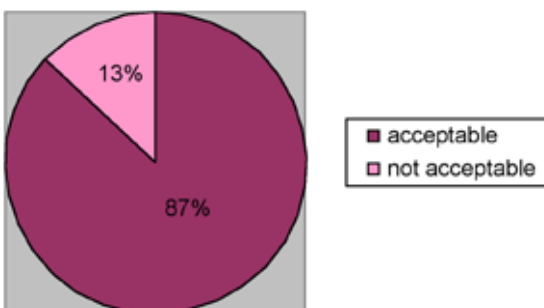
When asked if they would find this delineator acceptable in the pedestrian environment, 87% (13) of respondents said they would. No participants reported any problems with this delineator.

**Figure 39:** Mobility impaired participants – 30mm slope  
Acceptability in the pedestrian environment

Results from the video analysis also indicate that the 30mm slope was popular with mobility impaired participants as not one participant failed to cross the 30mm slope. Furthermore, the 30mm slope produced the slowest Total Heart Beat Index out of all the design features in 40% (6/15) of the participants, indicating that they were the least stressed when crossing this delineator. Two thirds (67%, 10) of the mobility impaired participants also recorded their fastest travelling speed when using this delineator, suggesting that these participants found this delineator the easiest to cross.

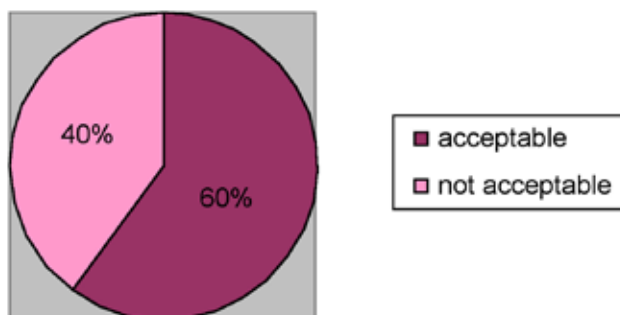
60% (9) of participants felt that they would find this delineator acceptable in a pedestrian environment while 40% (6) said they would find it unacceptable.

**Figure 45:** 50mm slope: Mobility impaired participants  
Acceptability in the pedestrian environment

Analysis of the video data revealed that 27% (4/15) of the mobility impaired participants failed to climb the 50mm slope. This was the highest failure rate out of all the delineators for the mobility impaired participants. In addition, two participants had their slowest travelling speed when using this delineator and one participant recorded his highest Total Heart Beat Index for this feature.

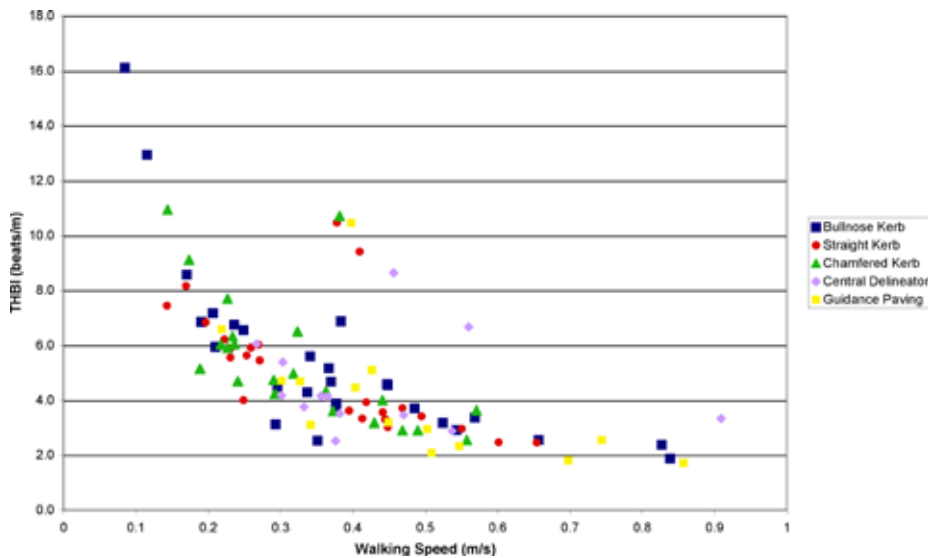
**Figure 46:** Travelling Speed vs Total Heart Beat Index for VI group

This figure shows how the effort of walking along a particular delineator varies according to the travelling speed for the VI group. Bernardi et al. (1999)<sup>11</sup> showed that for lower walking speeds there is an increased physiological cost. If one delineator was easier to follow than another, we would expect the values recorded for that delineator to have comparable travelling speeds with lower THBI. The results appear to be distributed across the full range, indicating that although some people have had more problems with one or more delineator, there is no clear best or worst delineator.

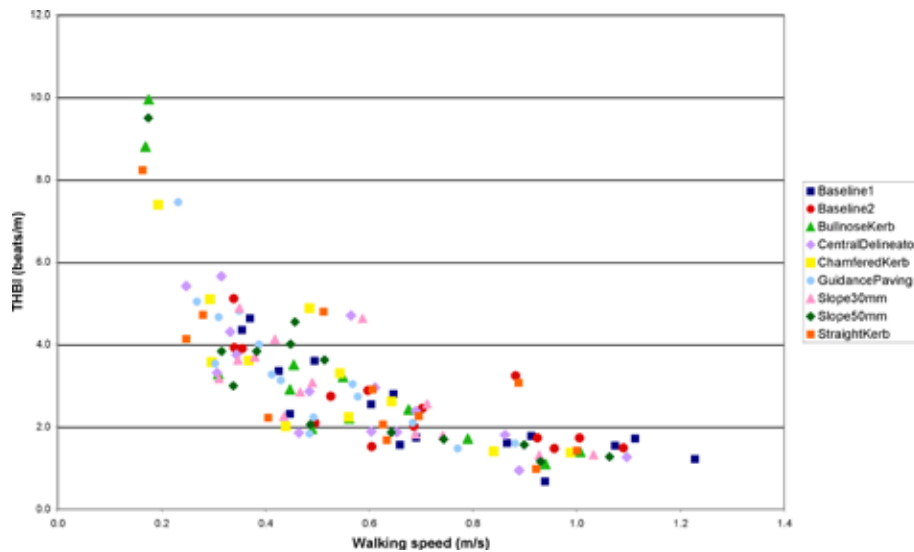
**Figure 47:** Travelling Speed vs Total Heart Beat Index for MI group

This figure shows how the effort of travelling along a particular delineator varies according to the travelling speed for the MI group. Slower speeds show a higher cost of travelling. As would be expected, the baseline trials, although highly variable, are not included in the group of the slowest travelling speeds. This slowest group, at around 0.2m/s, includes the straight kerb, the bullnose kerb, the chamfered kerb, the guidance paving and the 50mm slope (1:4). This indicates that the 30mm slope (1:7) and the central delineator were the least problematic obstacles.
